ENGINEERING REPORT

FAA CONTRACT NO. DTFA03-02-C-00044 PHASE 1, CLIN 0001b (TASK 2) - AIRCRAFT INFORMATION REPORT

The candidate aircraft for this work is Boeing 727-232 line number 1000, registration number N474DA. This specific aircraft was chosen because its 59,497 accumulated cycles are very close to the 727 Design Service Goal of 60,000 cycles. In addition, N474DA retired before the lap joint cracking that is the subject of Boeing Service Bulletin 727-53A0222 and AD 99-04-22 was discovered in service. Therefore, although N474DA is well beyond the 35,000 cycle threshold in 727-53A0222 for NDT inspections, no lap joint NDT inspections or repairs were accomplished during service.

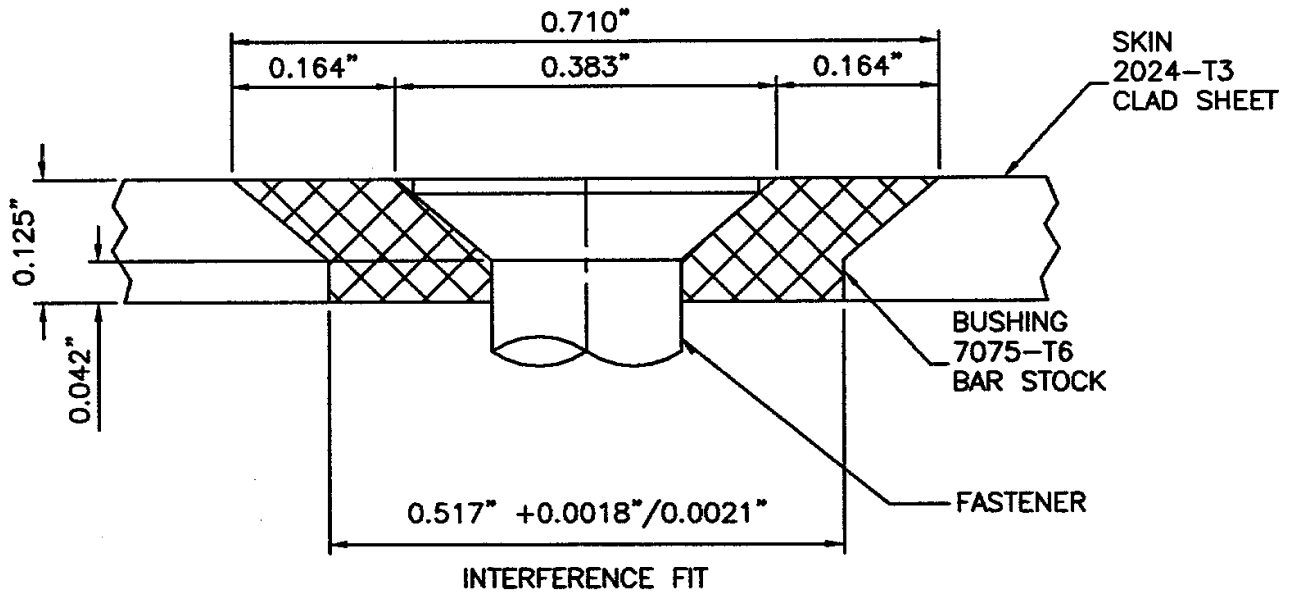
Repair Figure 2, 372543-14 (Wing Flap)

ER/A NUMBER	372543-14	DATE	17-JUNE-99	CYCLES	
DAMAGE SUMMARY WING / #3 MID FLAP / AFT LOWER SKIN PANEL WAS FOUND WITH TWO SKIN FASTENER HOLES DAMAGED. THE TWO HOLES ARE LOCATED AT: 1. WBL 84.80 AT THE EDGE OF THE SKIN PANEL 2. WBL 134.3 AND 2" FROM THE FWD EDGE OF THE SKIN PANEL					
REASON		CORROSION			
REPAIR SUMMARY 1. A BUSHING REPAIR FOR DAMAGE AT WBL 134.3 (FIG. 2) 2. AN EXTERNAL DOUBLER REPAIR FOR DAMAGE AT WBL 84.80 (FIG. 3)					
ORIGINAL HOLE SIZE		1. 0.190/0.194" DIA. AT WBL 84.80 2. 0.250/0.254" DIA. AT WBL 134.3			
SKIN THICKNESS		0.125" 2024-T3. AT WBL 134.3 0.040" 2024-T3. AT WBL 84.80			
DOUBLER THICKNESS		0.125" 2024-T3 AT WBL 84.80			
FASTENER TYPE AND DIAMETER		BACB30FN6 NAS1097D5 BACB30NN3-5

COUNTERSUNK BUSHING FOR OVERSIZED HOLE
CLEANED UP HOLE SIZE 0.517"
